Compliance Evaluation Inspection Report

USPS White Plains - Vehicle Maintenance Facility

White Plains, NY

November 29, 2022

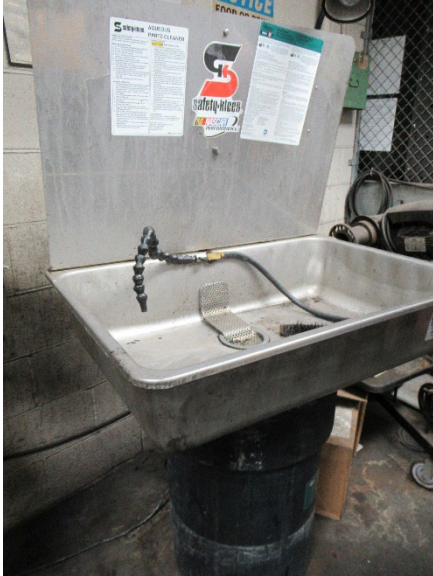
Photo 1 – Stationary parts washer

Following the opening meeting and discussion of applicability, we toured the facility with Mr. Danny Hill, an office worker at the VMF, since Mr. Peebles was new to the facility and had a meeting about to begin. We started our tour by inspecting the VMF's multiple parts washers, which include the primary stationary unit (Photo 1), two portable units (Photos 2), and an additional portable parts washer specifically for servicing breaks (Photo 3).

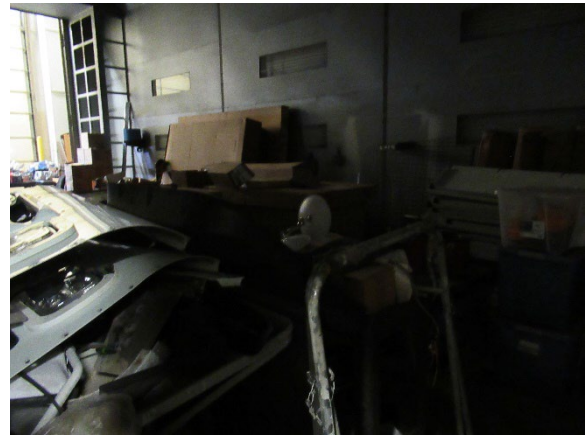
Photo 4 – Paint booth storage

Following the parts washers, we visited the spray paint booth that is currently not in service. The paint booth is being used as a storage area for the facility (Photo 4). Mr. Hill described the filters being removed and disposed of as hazardous waste. However, he did not believe it was fully decommissioned and stated that the vent from the paint booth to the roof of the building was not capped. Mr. Hill stated that the paint booth has not been used and has been considered out of commission by the facility since 2017. He also stated that no one has been trained since that time.

Mr. Peebles provided an email chain with VMF Northeast Area regional leadership, Ms. Donna Gill, and Mr. Howard Snowman, the Safety Manager for USPS White Plains, in May 2018 regarding the efforts to decommission the spray paint booth. While it has not been removed from the permit or decommissioned by the NYSDEC, the booth is currently not operable and has not been since May 2018; the VMF does not have anyone trained to conduct spray booth operations; and the booth is being used as a storage area in the facility.

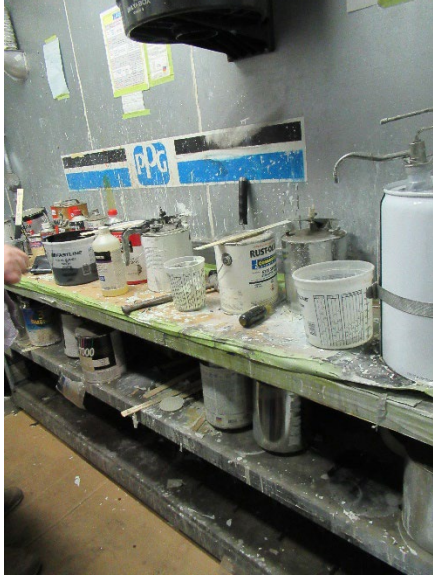
Photo 5 – Hand paint station

In addition, the facility has a secondary room to the side of the paint booth that uses the roof vent. The secondary room is used only for mixing paint by hand (Photo 5). Outside of the paint room, there was painting occurring on a vehicle; however, it was done using an aerosol spray paint can. At the time of the painting, the staff member was not using a mask and EPA brought that to the attention of the VMF manager during the closing meeting.

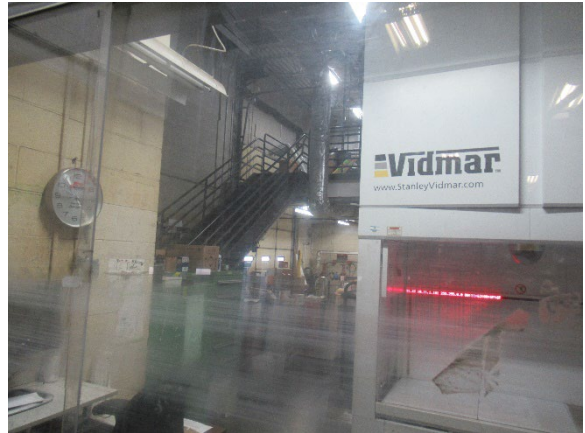
Photo 8 - Lack of yellow treads

- Lack of yellow tape on stairs;
- Staff using strong aerosol spray paint can without mask of any kind;
- Spray paint booth not officially decommissioned by NYSDEC; and
- Full catch basins in car washing station.

OSHA: Observed stairs without yellow safety tape. Additionally, strong chemical smells were present follow spray painting and the worker was not using a mask of any kind.
